Attachment A: Digital Images

September 19th, 2008

BOE Building 1st Floor Janitor's Plenum Area

Sacramento, CA

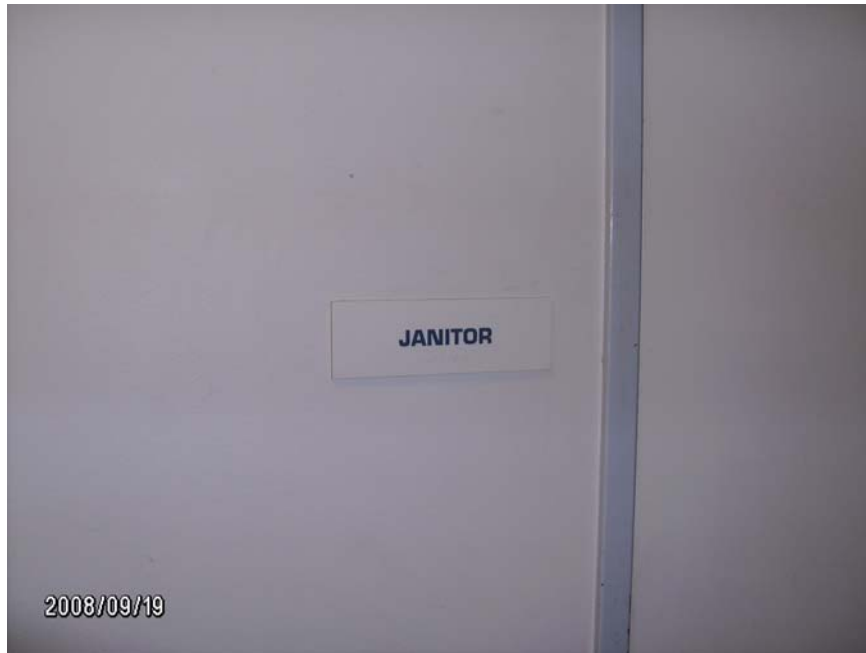
- 1) Image of First Floor Janitor access doorway within BOE Building (Subject Building) located at 450 N Street, Sacramento.

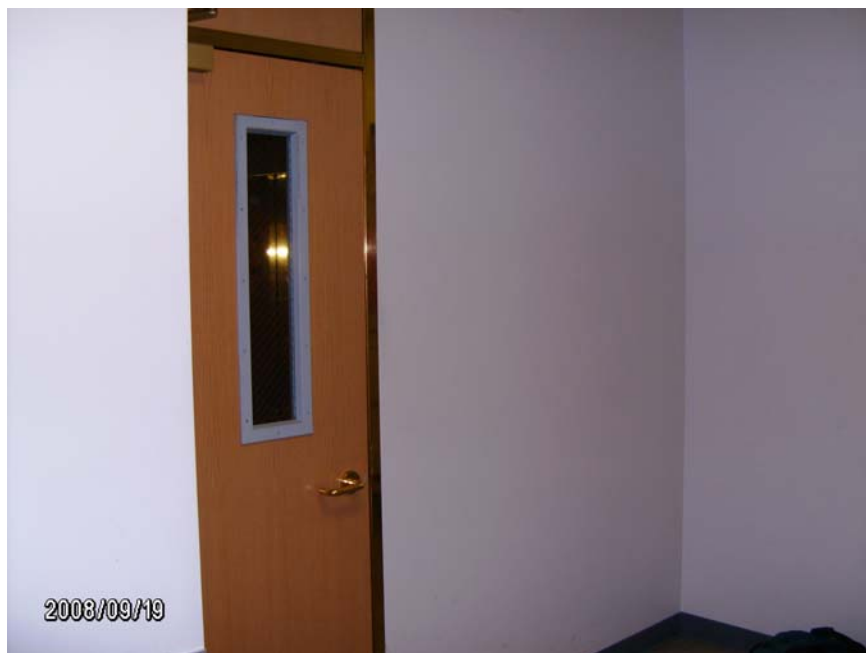
- 2) Image of doorway leading to elevator lobby adjacent to janitor's room at time of inspection.

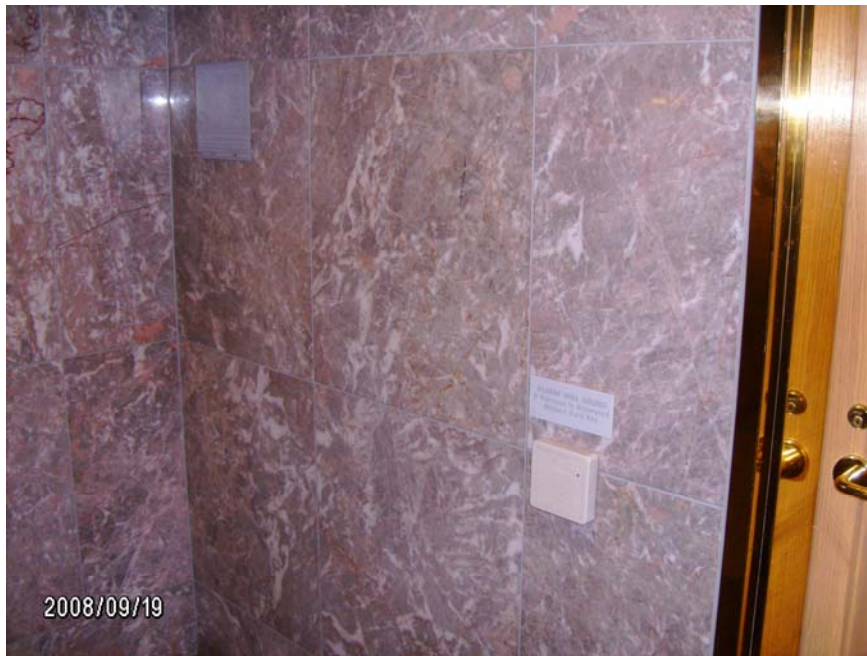
- 3) Image of marble wall material within elevator lobby area adjacent to shared wall of first floor janitor room area.

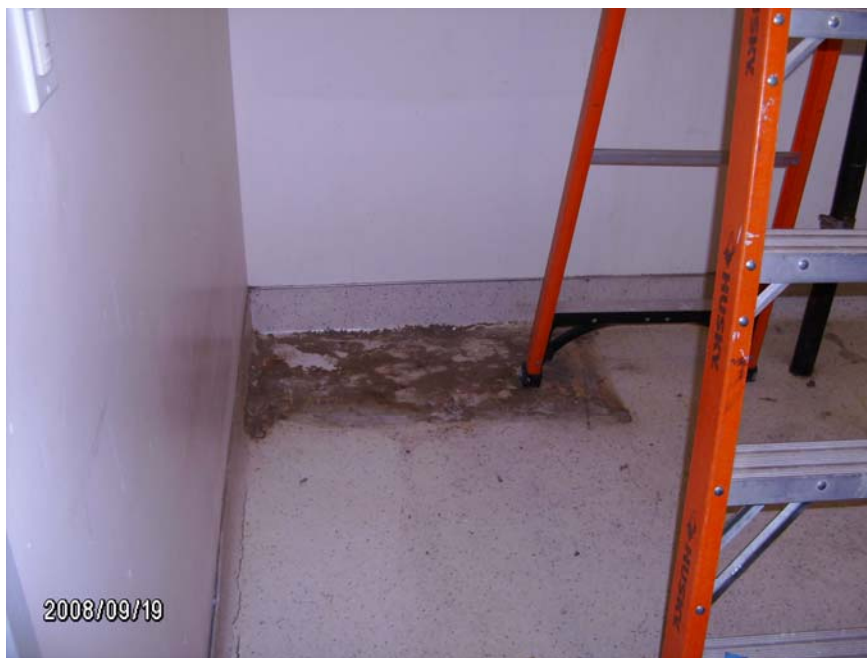
- 4) Image of stained flooring and cracking present within janitor's room at time of assessment.

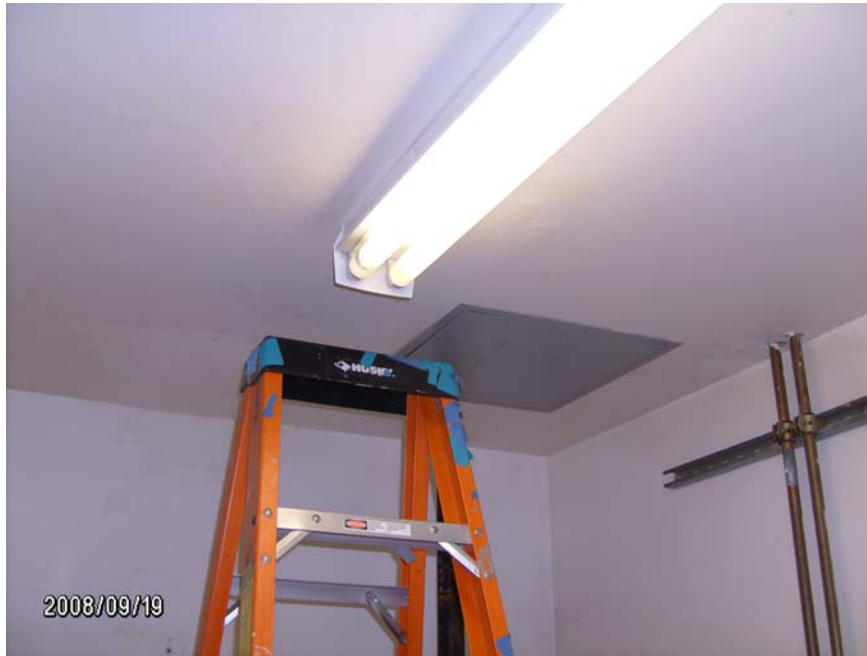
5) Image of inspector access panel on ceiling within janitor's room.

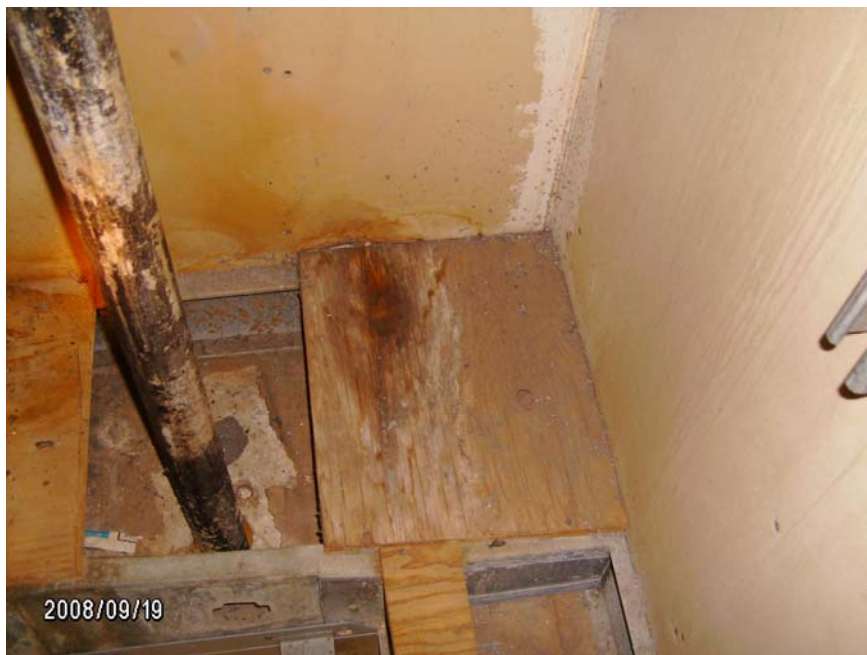
6) Image of stained wallboard and plywood viewed from within janitor's plenum area at time of assessment.

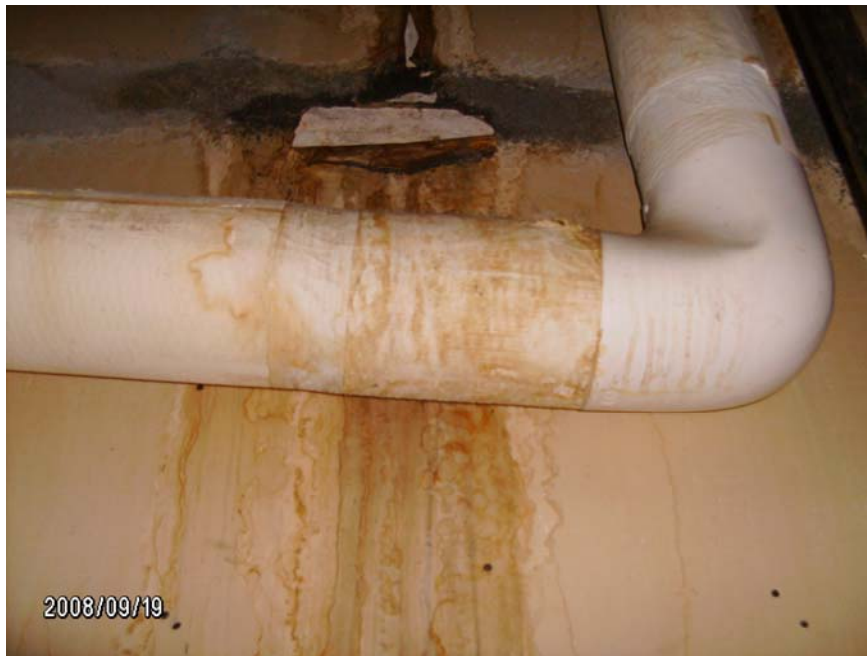
- 7) Close-up image of stained plumbing and plumbing insulation materials located on western wall of janitor's plenum.

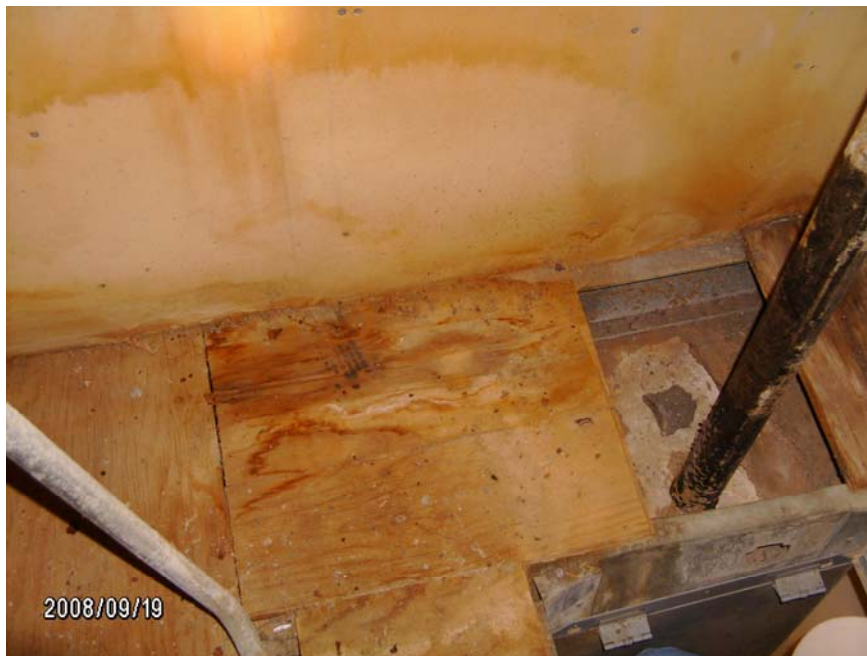
- 8) Image of staining trails and physical dripping from plumbing systems as viewed within the janitor's plenum area.

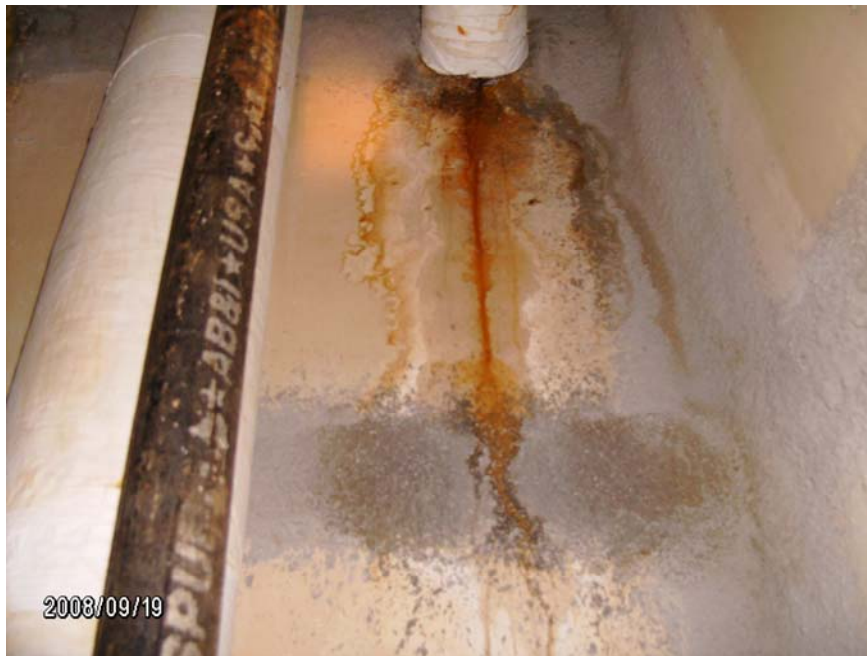
- 9) Additional image of plumbing structures and staining trails present on wallboard surfaces within western wall of janitor's plenum area.
